PISTOL CREEK RESTORATION

CALIFORNIA LAND STEWARDSHIP PRGRAM FISH FRIENDLY FARMING ENVIRONMENTAL CERTIFICATION ARMING PROJECT REPORT

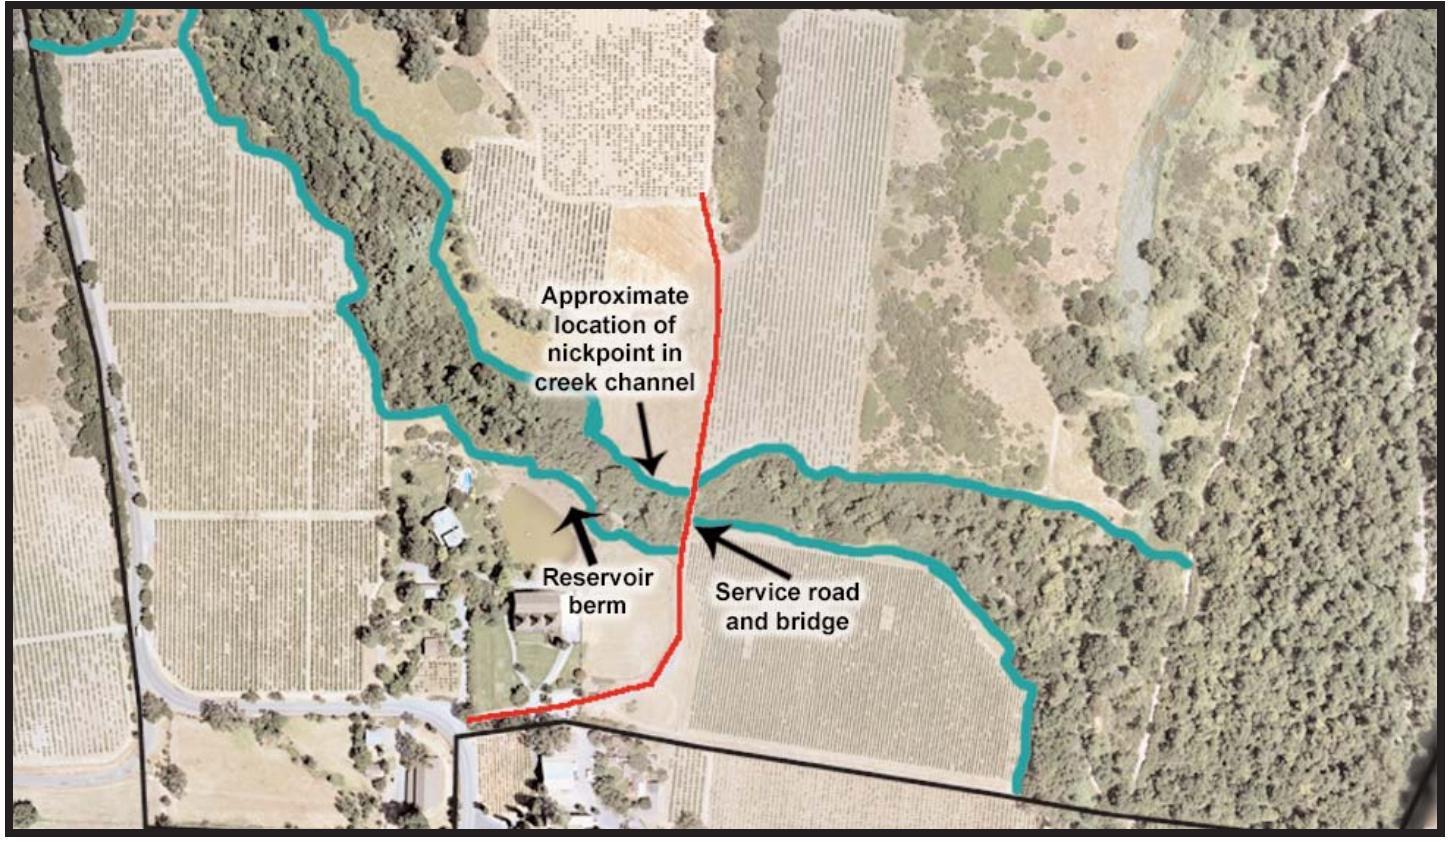
The 2004 field review found a 15-18 ft. nickpoint is located upstream of the Service Road bridge. On the right bank above Upstream of the nickpoint the creek channel had a meandering form with gravel bars and pools, a floodplain and moderate stream bank heights. Downstream of the nickpoint the creek has 15-18 ft. bank heights and is incised with no floodplain. The likely cause of the incision is the gravel extraction in the Russian River which has been occurring since the 1960's. The pattern of channel erosion is greatest at the downstream end of the creek where it meets the Russian River indicating the erosion is progressing from the river channel up the creek channel rather than being caused by a source in the creek's watershed which would tend to cause erosion from upstream to downstream. In addition the watershed of Pistol Creek is only 1.5 square miles and is in rural land uses.

In the January 1, 2006 flood the nickpoint migrated upstream and undercut and collapsed the Service Road bridge. Just upstream of the nickpoint is the base of the reservoir berm. Further progression of the incision and bank erosion could destabilize this berm and cause catastrophic failure. Such a failure would contribute significant fine sediment to the Russian River, a waterway listed as impaired by this pollutant.

FIGURE 7 NICKPOINT LOCATION

Stabilize the nickpoint to avoid further erosion of the channel upstream and possible destabilization of the reservoir berm as Phase 1 of the project. A grade stabilization structure of large rock designed by the site engineer is recommended. The structure will need to extend downward into the streambed and outward into the banks to protect the upstream area from further migration of the nickpoint and degradation. It is likely that a set of pool structures may be needed just downstream of the grade control structure to allow for salmonid passage. It is recommended that NOAA-Fisheries be consulted for the design of these pools. A number of permits will be required for the structure including Section 404 and 401 of the Clean Water act, 1600 Fish and Game Code and possibly local approvals.

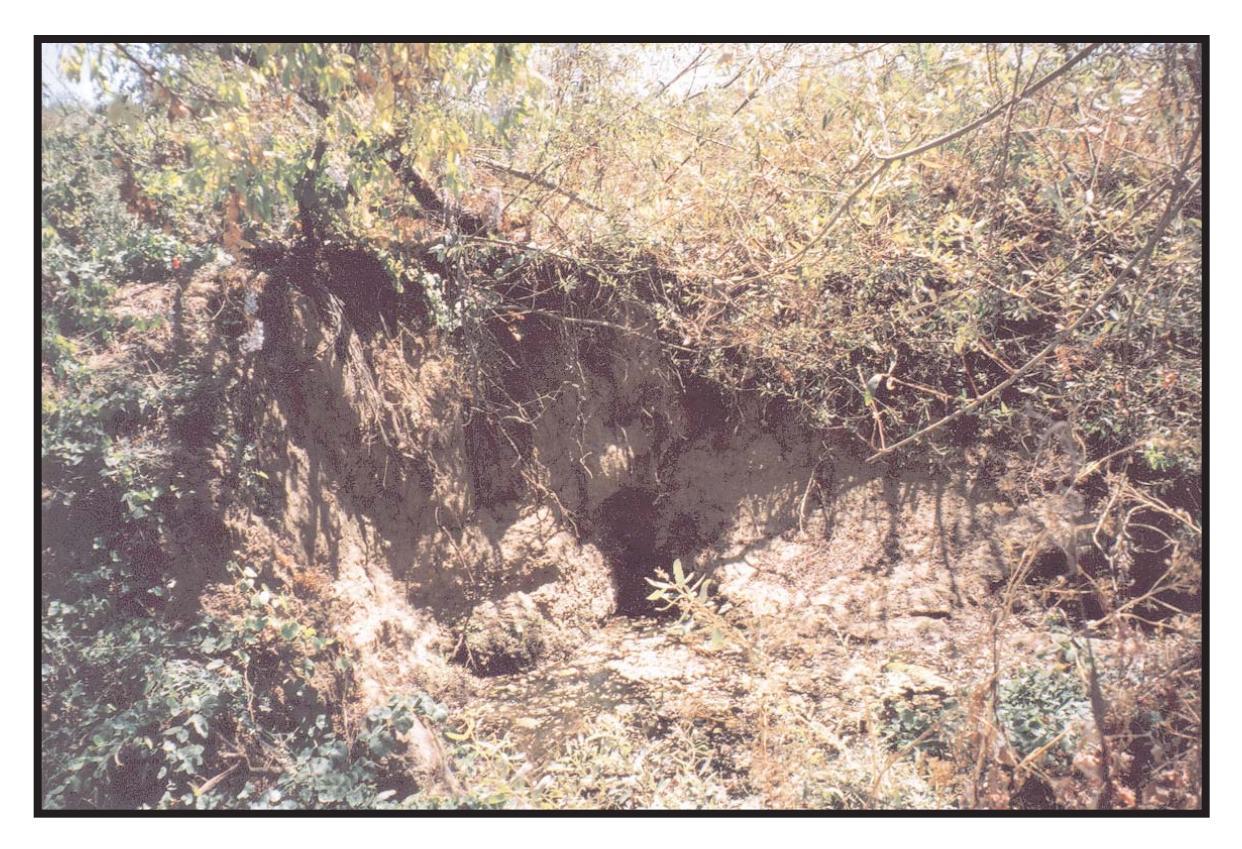
FIGURE 8 LEFT BANK ADJACENT TO NICKPOINT SHOWING ACTIVE BANK FAILURE

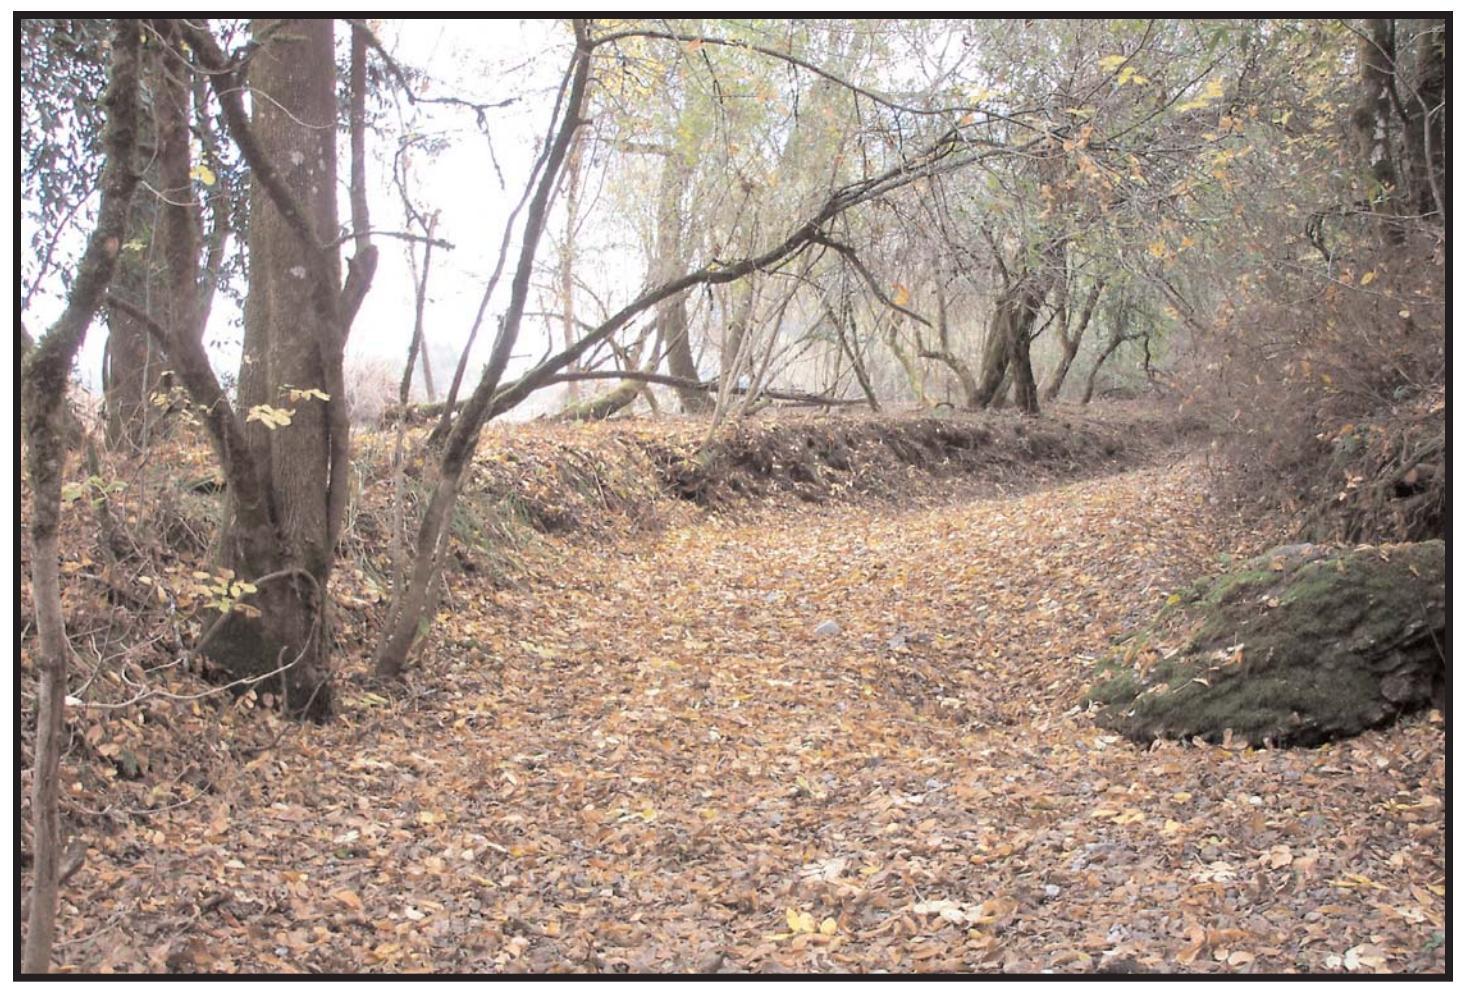
FIGURE 9 ABOVE: CHANNEL OF PISTOL CREEK UPSTREAM OF NICKPOINT HAS LOW BANKS AND SHOWS LITTLE INCISION FIGURE 10 BELOW: HARD ROCK OUTCROPS OCCUR ON RIGHT BANK IN UPSTREAM AREA

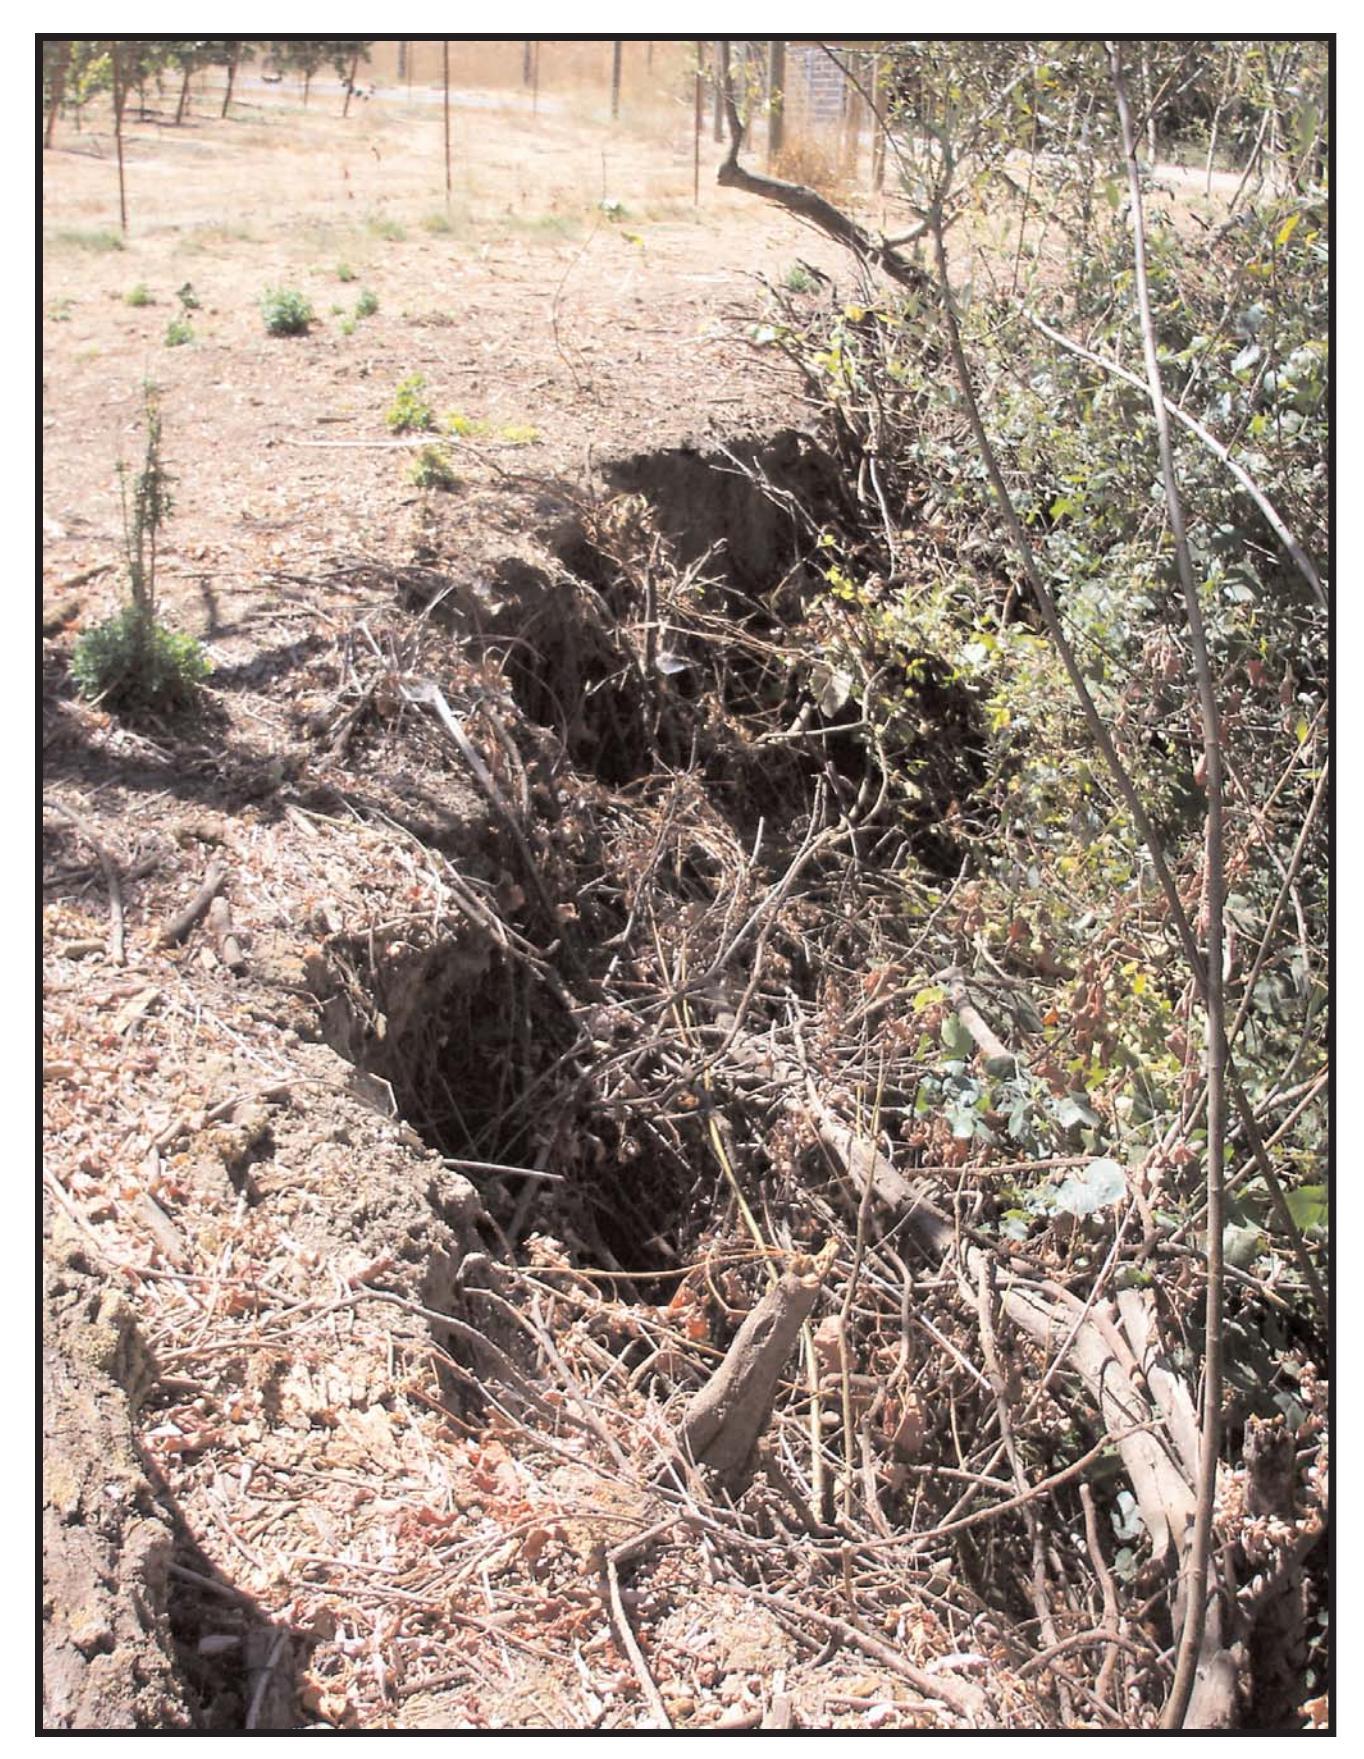
FIGURE 11: TOP OF STREAM BANK DOWNSTREAM OF NICKPOINT IN 2005 SHOWING IMMI-NENT BANK FAILURE AND LOSS OF RIPARIAN HABITAT

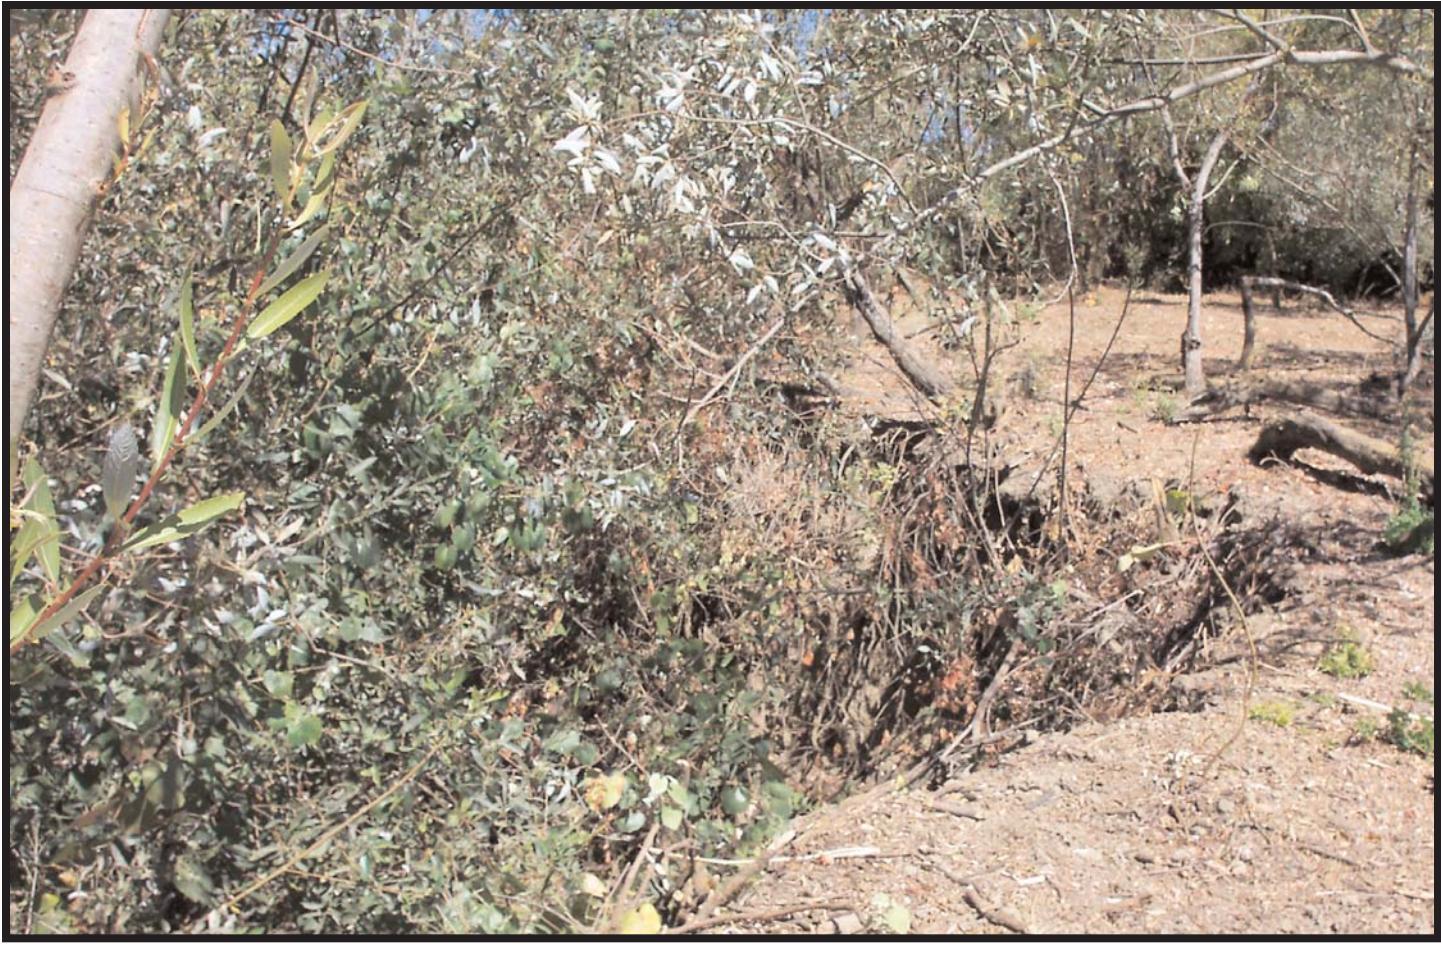
FIGURE 12 ABOVE: BANK FAILURE DOWNSTREAM OF NICKPOINT IN 2005 FIGURE 13 BELOW: DOWNSTREAM OF THE NICKPOINT WITH EROSION CAUSED BY OVERLAND FLOW RETURNING TO CHANNEL

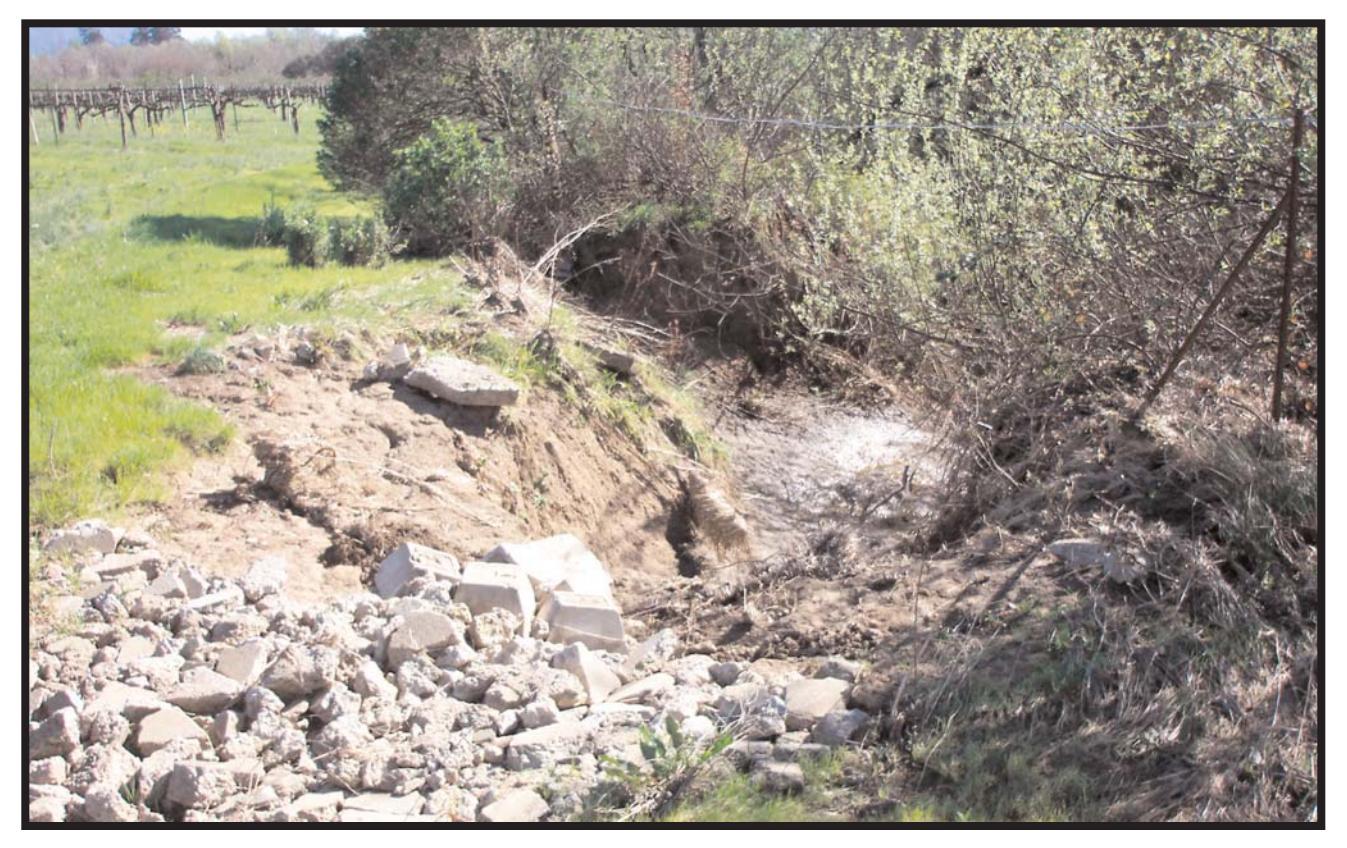
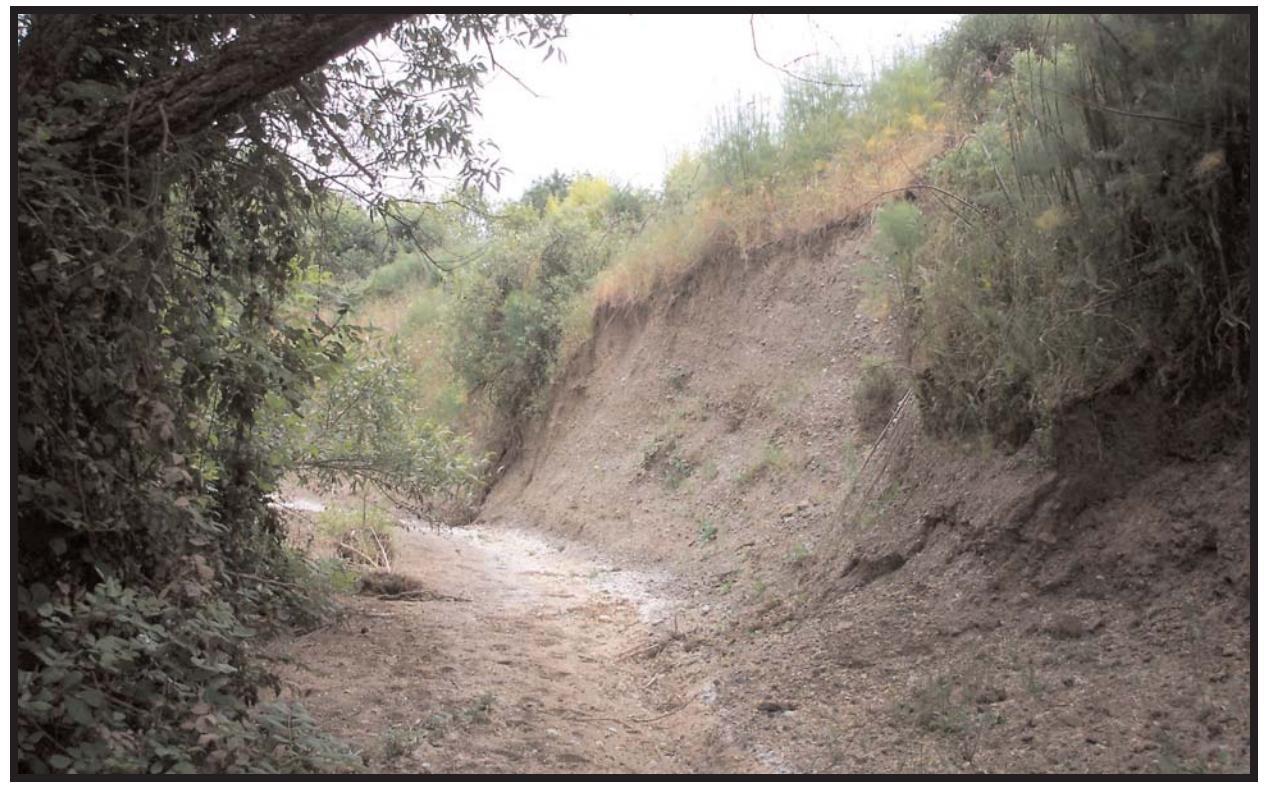
FIGURES 14 AND 15: TWO VIEWS ON LOWER PISTOL CREEK NEXT TO CONFLUENCE WITH RUSSIAN RIVER MIDDLE REACH SHOWING EROSION FROM INCISION
