WINE CREEK RESTORATION AND REVEGETATION PROJECT

Channel Incision and Habitat Restoration: Wine Creek

Wine Creek Summary of Observations and Measurements from April 4, 2003 Site Visit

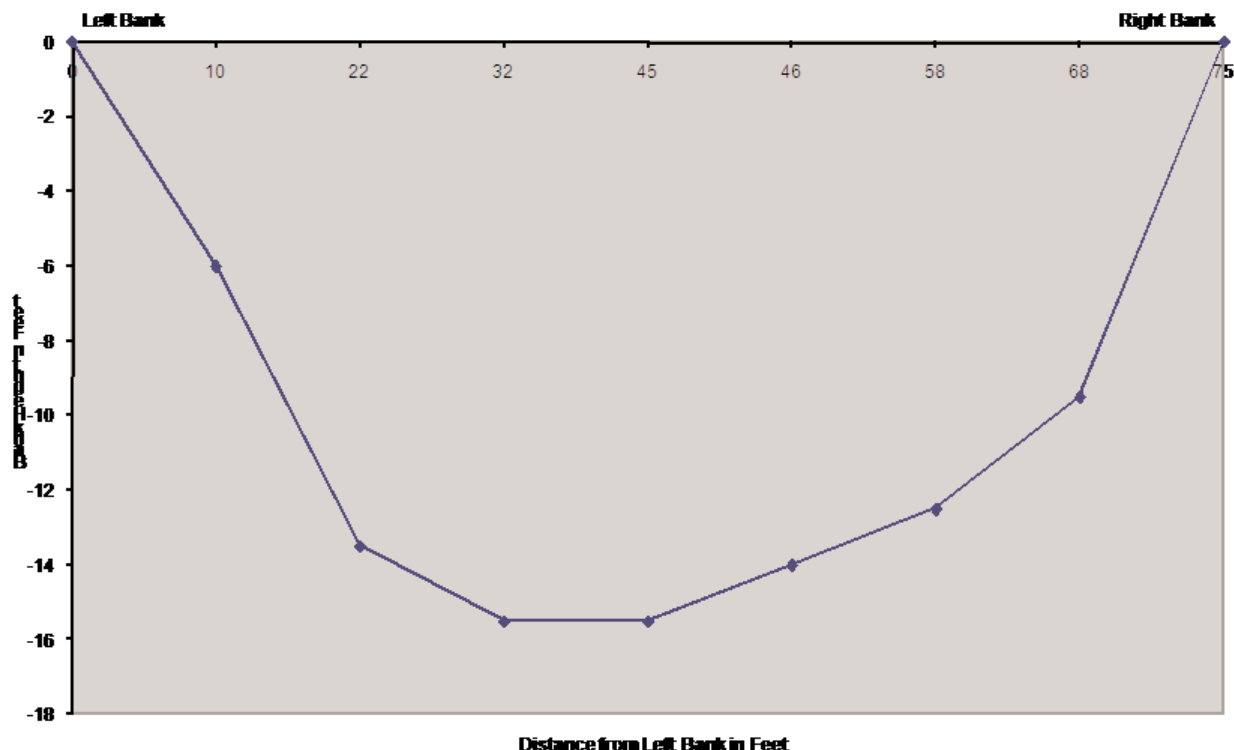
**Wine Creek
Cross Section #1
Downstream Area with New Floodplain**

| Measurement Location | Bankfull Channel Width | Total Riparian Corridor Width | Bank Heights | Comments |
|---|---|---|---|---|
| 1 | 23 ft. | 125 ft. | 15.5 ft. | Bank collapse has led to re-creation of natural, new, lower floodplain next to incised low flow channel. Riparian trees have colonized new floodplain. Detailed cross section #1 completed. |

In the lower area of Wine Creek near Dry Creek no changes to the active channel or new floodplain should be carried out except to revegetate the floodplain with native riparian species and set back the collapsed banks where needed to a more stable angle and revegetate them with native plants such as oaks and upland species.

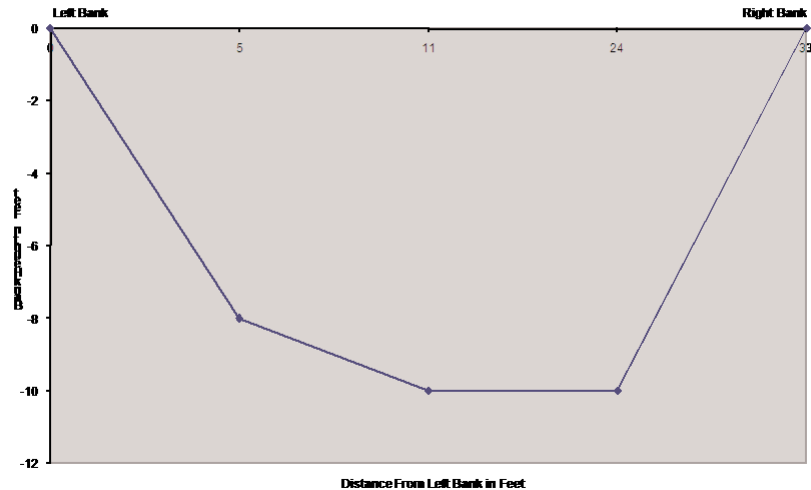
**Wine Creek
Cross Section #2
Upstream Area with Incised Channel**

| Measurement Location | Bankfull Channel Width | Total Riparian Corridor Width | Bank Heights | Comments |
|---|---|---|---|---|
| 13 | 19 | 94 | 10 | Flat bottom; highly incised channel; detailed cross section #2 completed |

In the incised areas the instream structures and willow walls should be left in place and the banks set back to a 3:1 angle or the abandoned floodplain excavated to create a new floodplain adjacent to the channel with revegetation with native riparian plants. The bank setback or floodplain creation would require 40-50 feet of the abandoned floodplain and should be designed to reduce impacts on the vineyard operation while serving to restore natural functions in the channel and increase the spawning habitat and riparian cover adjacent to the channel. This approach will increase the stability of the channel and reduce the likelihood of bank collapse affecting the vineyard. All plans for changes to the creek will be closely coordinated with the landowner. Construction should be done from the land side not water side of the channel. Implementation will require a precise survey of the channel, engineered plan, phasing of implementation, a location on-site for excavated material and coordination with the farming operation at all times.

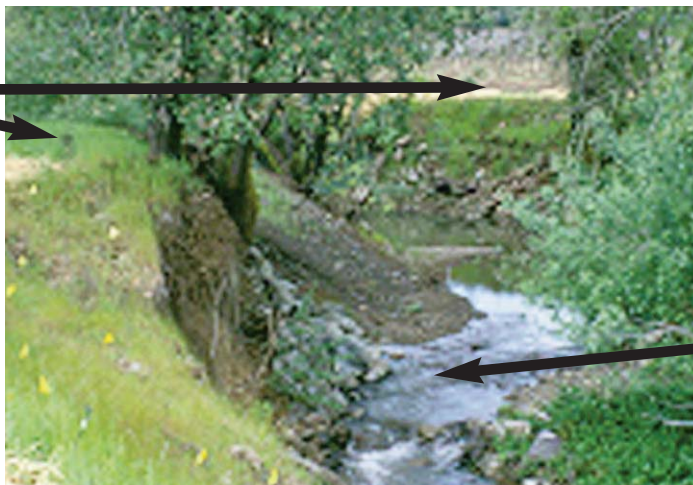
ABANDONED
FLOODPLAIN
OR TERRACE

The former floodplain, now 10 or more feet above the channel, no longer functions to spread out and slow floodwater and is isolated from the channel except in very large, infrequent flood flows. The plants along the abandoned floodplain, or terrace, may be able to withstand the incision of the channel if their roots can continue to reach groundwater as the summer water level recedes to the level of the lower incised channel. However, the abandoned floodplain is no longer able to support new riparian seedlings due to the lack of flood flows and natural processes. The high velocity incised channel is also unable to support new seedlings due to these altered processes. Eventually, as the channel gets deeper and the alluvial banks get steeper, the banks are undercut and collapse. As the banks collapse, the channel widens out and the bank material creates a new floodplain adjacent to the lower channel. Flood flows are able to spread out and slow down over the new floodplain and scour is greatly reduced. The channel adjustment re-establishes the natural relationship of the floodplain to its channel. This process of adjustment from a period of incision to the deepening and eventual widening of the channel with the reforming of a new floodplain is well documented in numerous creeks in the Russian River system.

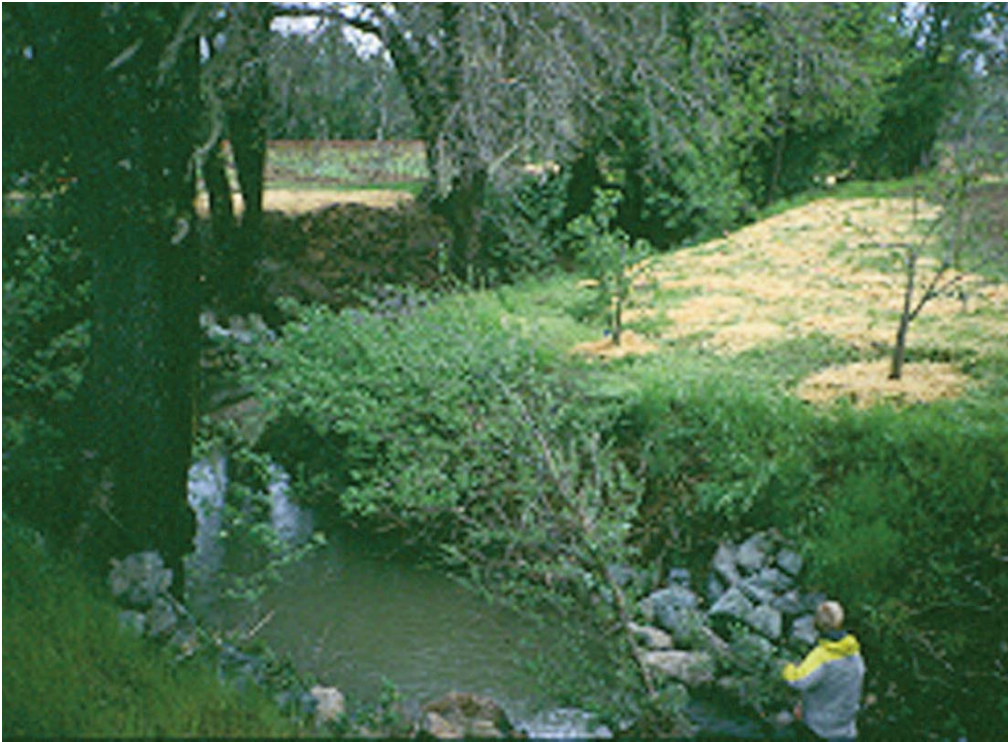
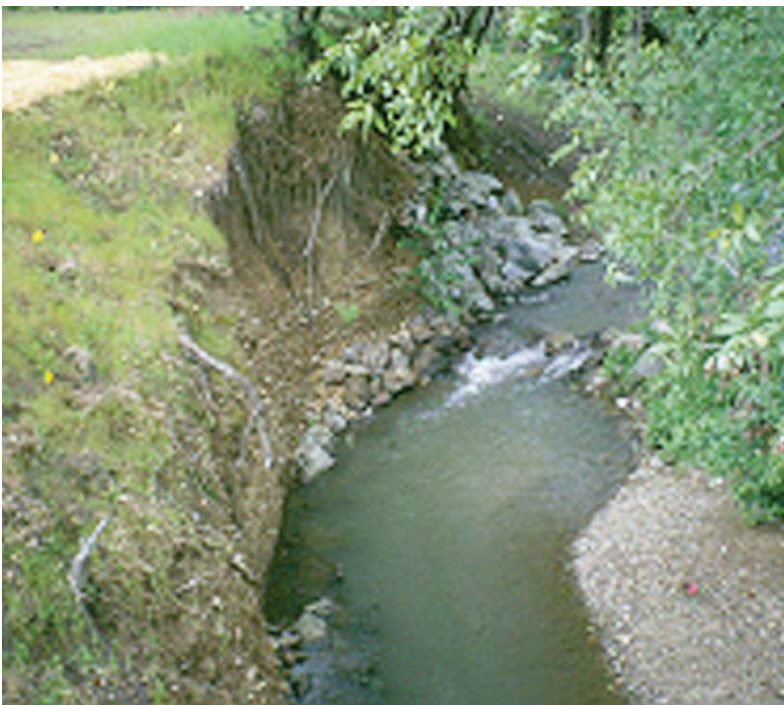
INCISED OR ENTRENCHED
CHANNEL

These photographs show the incision of the channel below its floodplain and the steep vertical nature of most of the stream banks along this section of Wine Creek. The entrenchment of the channel confines floodwater to the channel and increases velocities and scour of spawning areas.

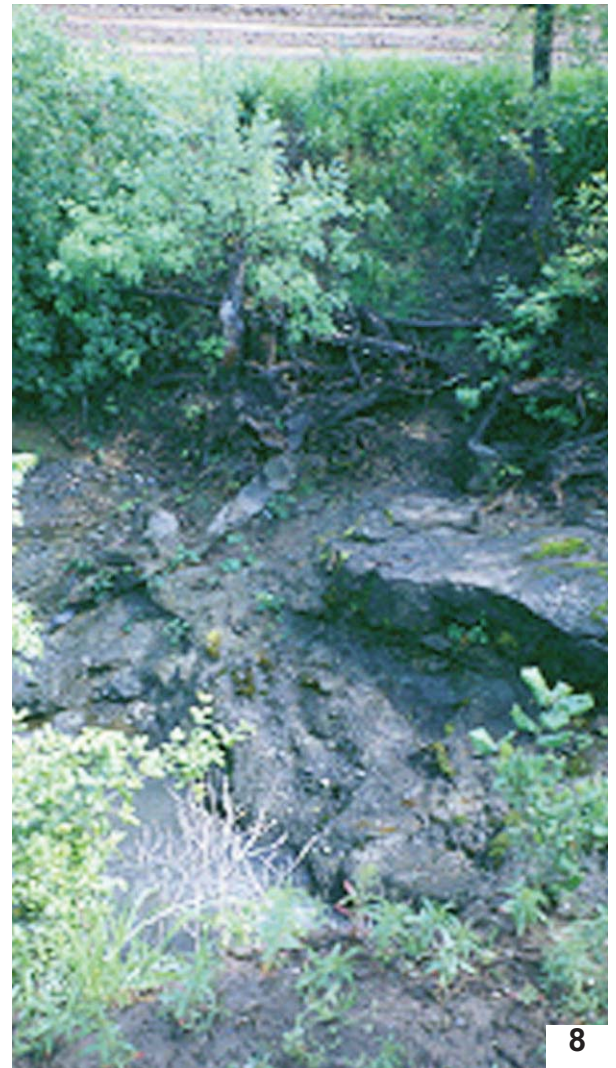
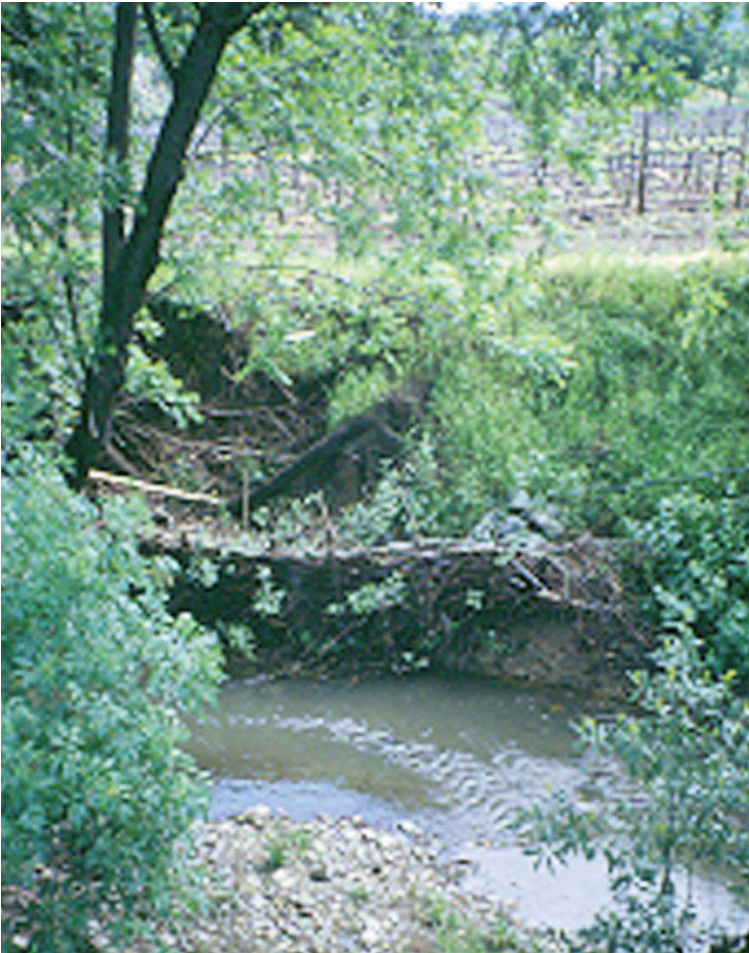
Bedrock exposed in the channel

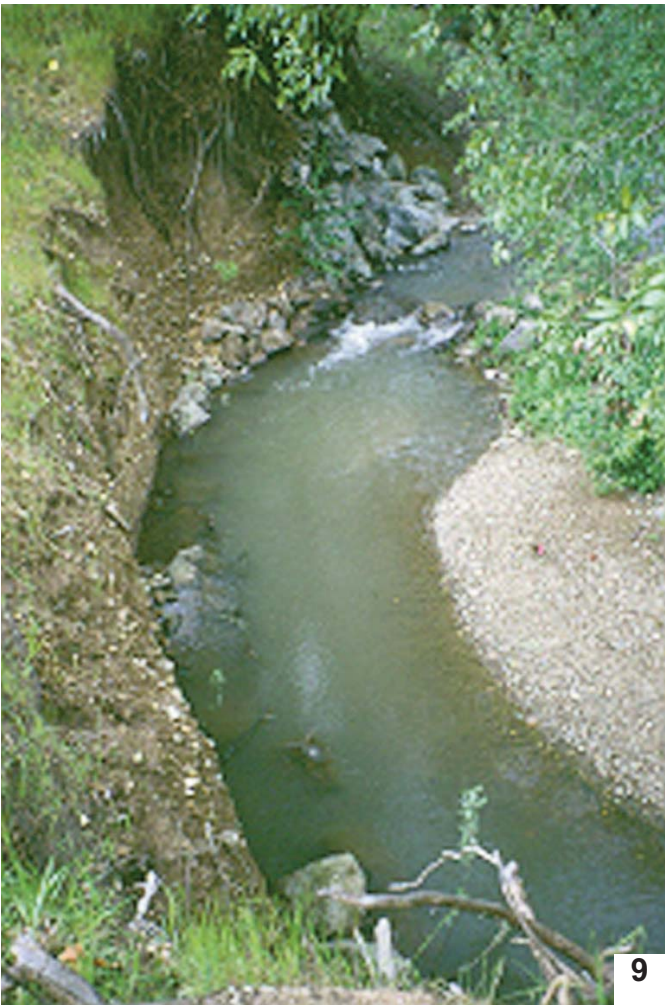
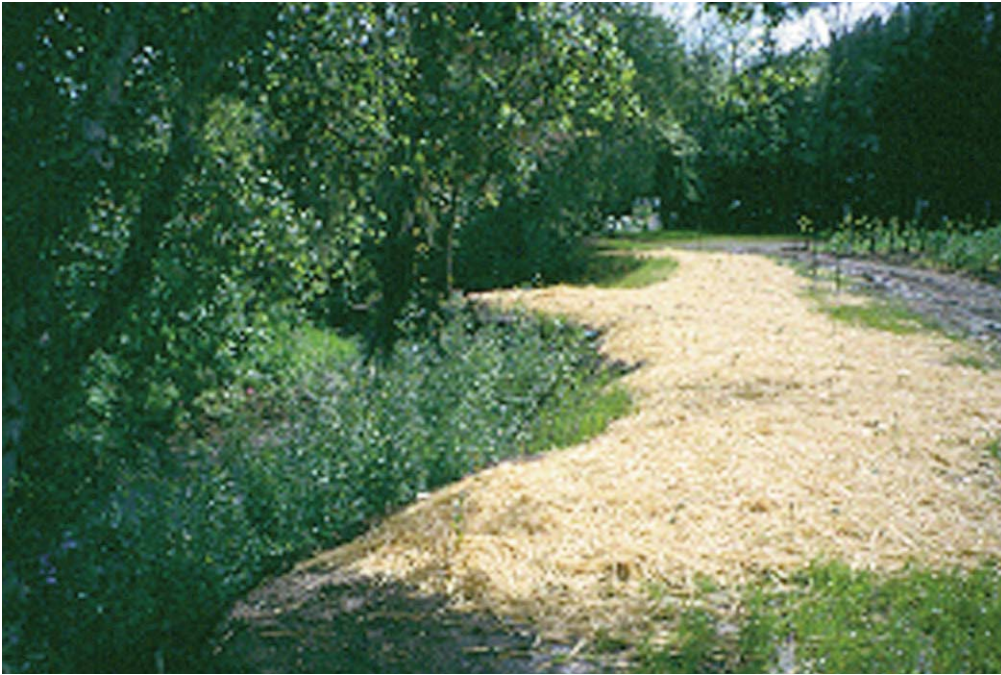
These photos show the undercutting and erosion around the willow walls indicating flow velocities continue to scour the channel due to the level of incision of the channel and the lack of a floodplain.

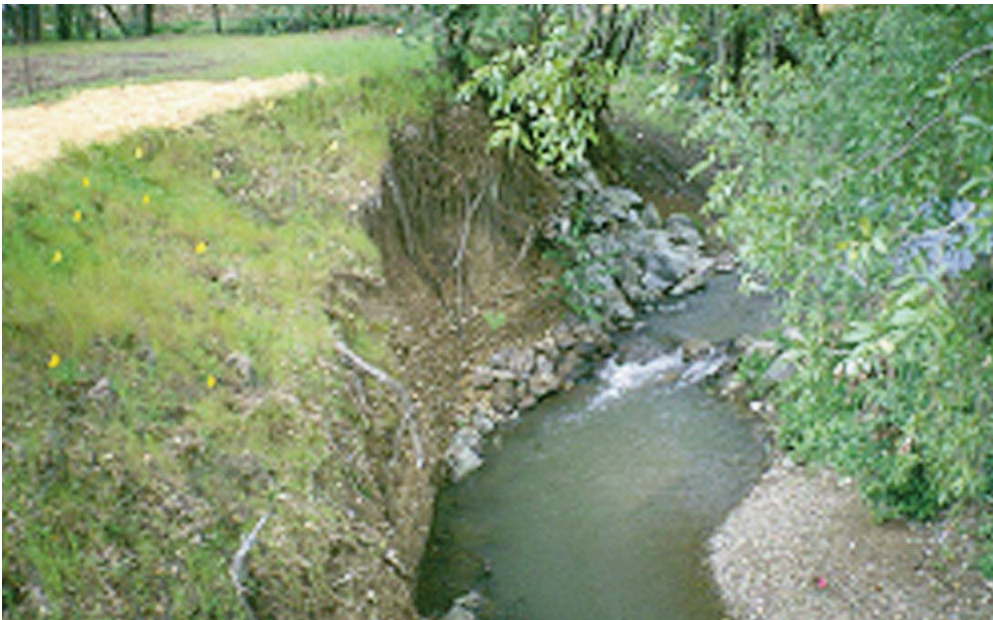
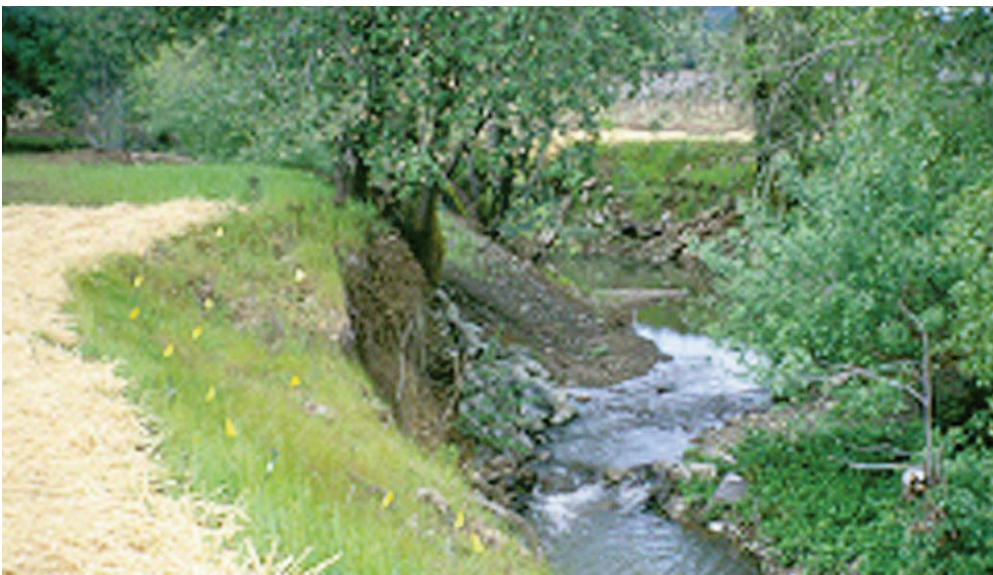
Incised channels undergo an adjustment involving the collapse of banks to re-create a new floodplain and reduce flow velocities. In these pictures the abandoned floodplain is collapsing due to the undercutting of banks. Revegetation efforts on the abandoned floodplain or terrace are unlikely to produce a sustainable system or reduce the bank collapse process

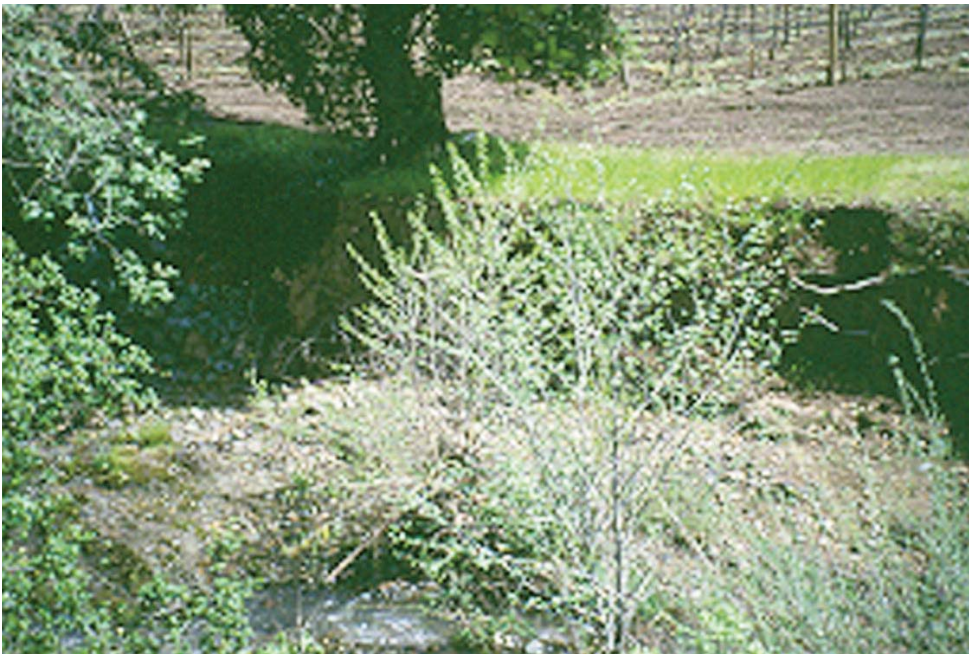
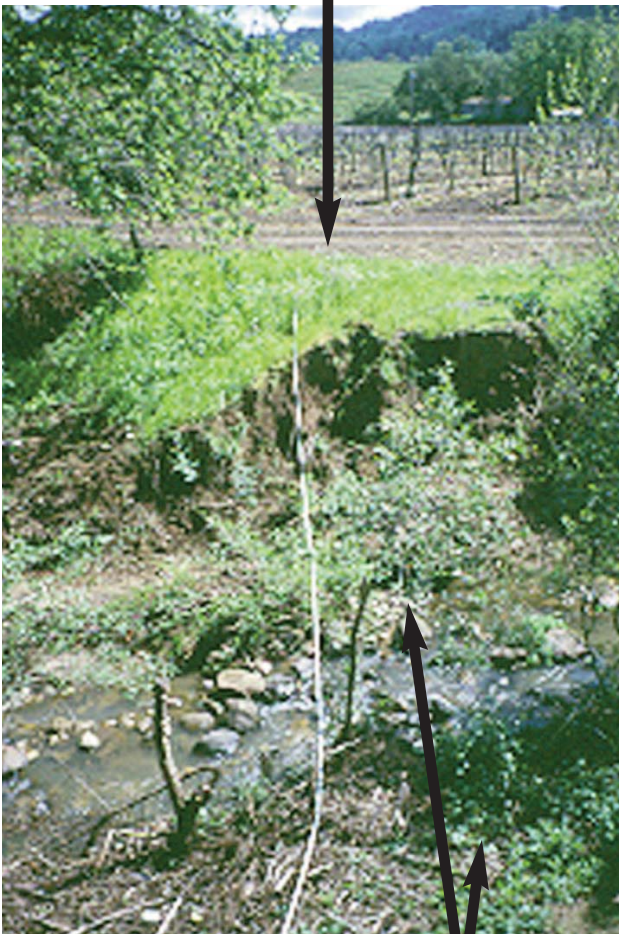
ABANDONED FLOODPLAIN

Downstream area of Wine Creek where bank collapse has created a new floodplain and riparian trees have colonized. The diagram depicts the process of adjustment this area of Wine Creek has undergone and upstream areas are also undergoing.
