PISTOL CREEK RESTORATION

CALIFORNIA LAND STEWARDSHIP PRGRAM FISH FRIENDLY FARMING ENVIRONMENTAL CERTIFICATION ARMING PROJECT REPORT

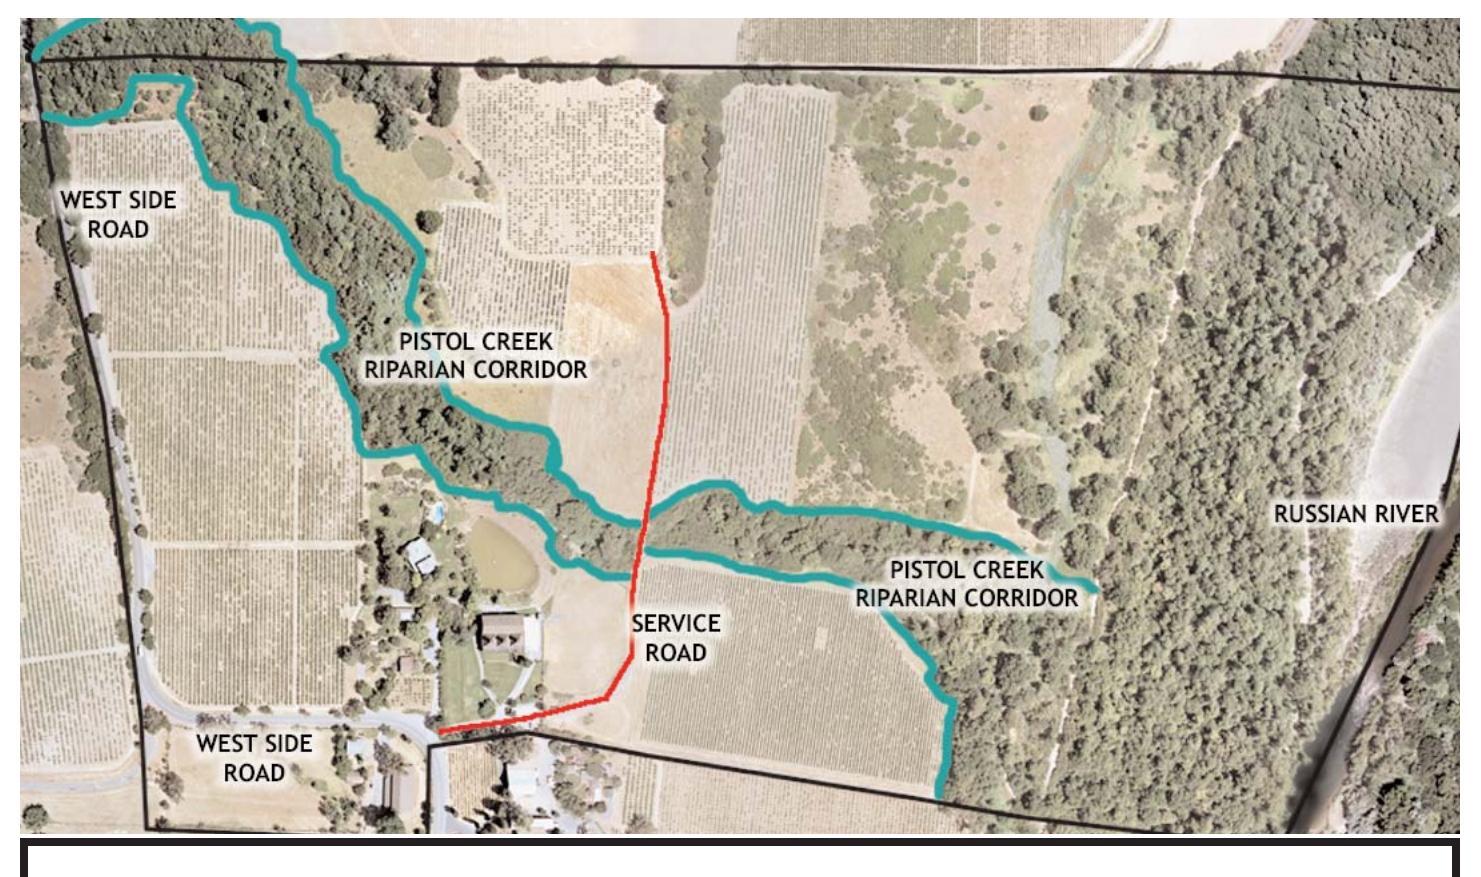
FIGURE 1 PISTOL CREEK RIPARIAN CORRIDOR ON HOP KILN WINERY SITE

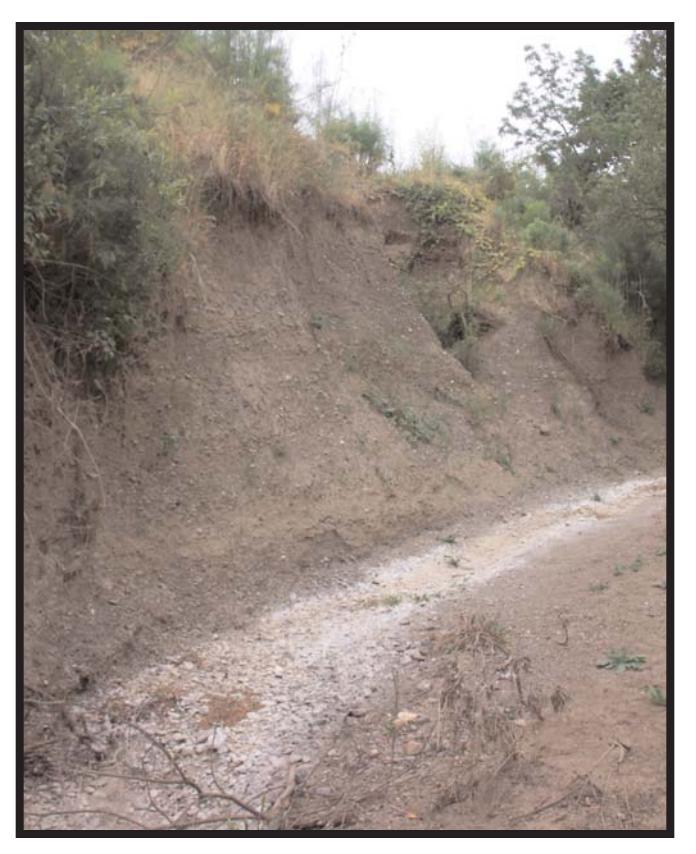
FIGURES 14 AND 15: TWO VIEWS ON LOWER PISTOL CREEK NEXT TO CONFLUENCE WITH RUSSIAN RIVER MIDDLE REACH SHOWING EROSION FROM INCISION
