WINE CREEK RESTORATION AND REVEGETATION PROJECT

Channel Incision and Habitat Restoration: Wine Creek

Wine Creek Summary of Observations and Measurements from April 4, 2003 Site Visit

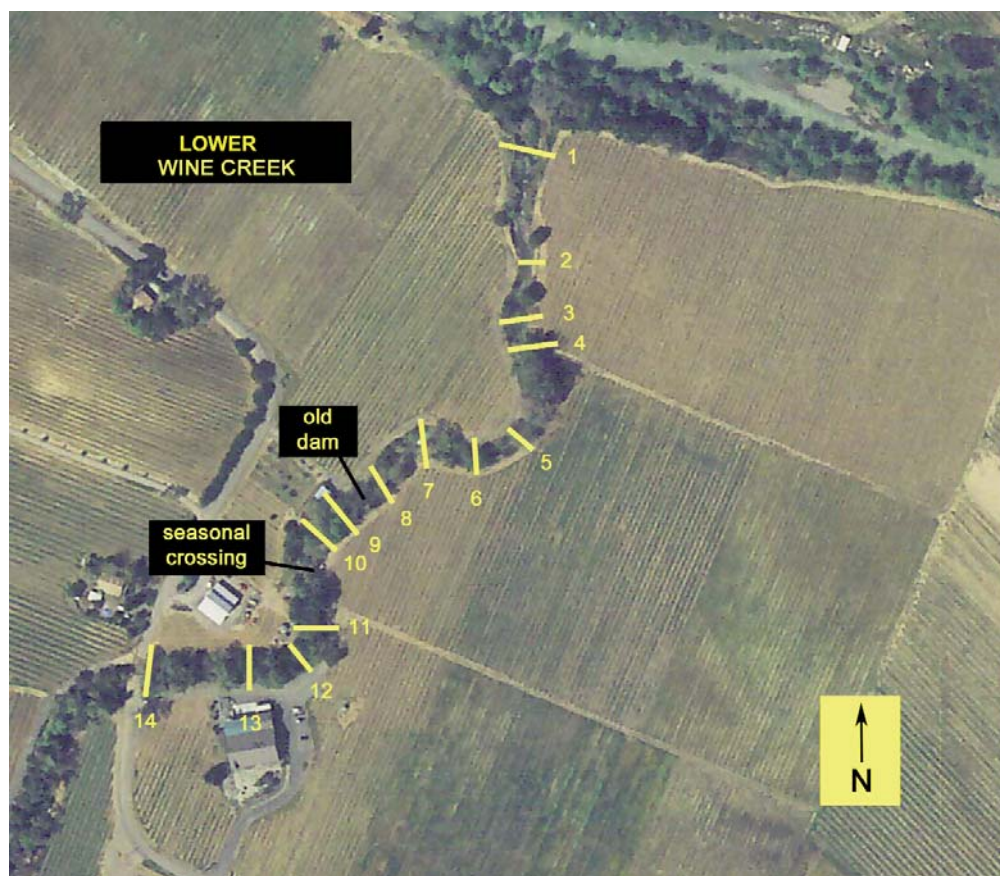
We evaluated the condition of lower Wine Creek. We measured two cross sections and measured bank heights at fourteen locations. In particular, we evaluated the relationship of the channel, the new floodplain forming in the downstream section and the abandoned floodplain. Table 1 and Graphs 1 and 2 summarize the information we collected and the figure below illustrates the locations where the measurements were taken.

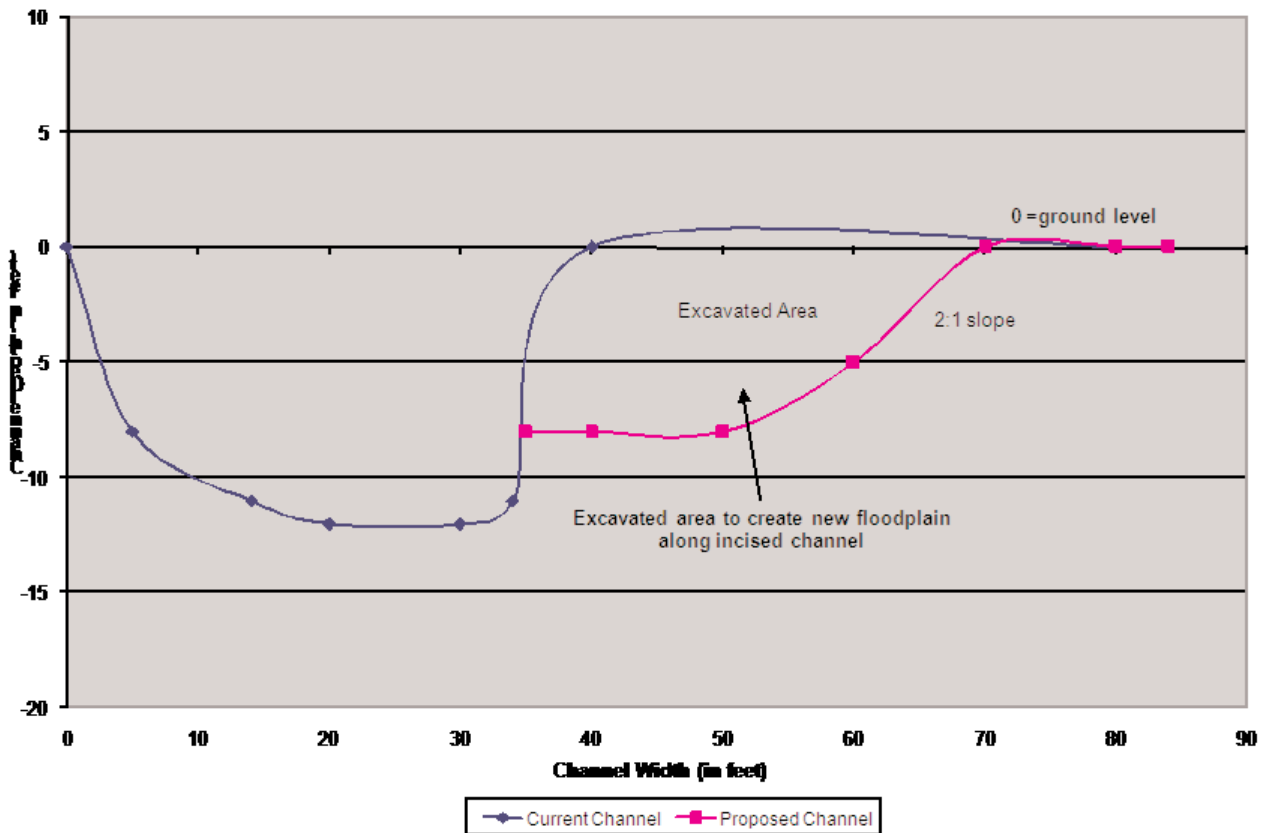
Wine Creek

This graph represents a restoration concept for Wine Creek. Some features that can be adjusted include: the 3:1 slope which can be steeped to 2:1 reducing the overall excavation and change in agricultural land, the elevation of the new floodplain above the existing channel may be revised as the bankfull channel is surveyed in detail and the bankfull depth is better determined, and the overall width of the new floodplain may also be revised based on detailed site surveys. Additional cross sections for wine creek and the quantities of material to be excavated are attached.

In the incised areas the instream structures and willow walls should be left in place and the banks set back to a 3:1 angle or the abandoned floodplain excavated to create a new floodplain adjacent to the channel with revegetation with native riparian plants. The bank setback or floodplain creation would require 40-50 feet of the abandoned floodplain and should be designed to reduce impacts on the vineyard operation while serving to restore natural functions in the channel and increase the spawning habitat and riparian cover adjacent to the channel. This approach will increase the stability of the channel and reduce the likelihood of bank collapse affecting the vineyard. All plans for changes to the creek will be closely coordinated with the landowner. Construction should be done from the land side not water side of the channel. Implementation will require a precise survey of the channel, engineered plan, phasing of implementation, a location on-site for excavated material and coordination with the farming operation at all times.
